Managing River Oaks and other in-stream vegetation in Gravel-bed Rivers on the NSW Coast

This fact sheet provides land managers with an understanding of the role of in-stream vegetation in the dynamics of the river channel, as well as tips and techniques for managing vegetation that grows in rivers with gravel beds.

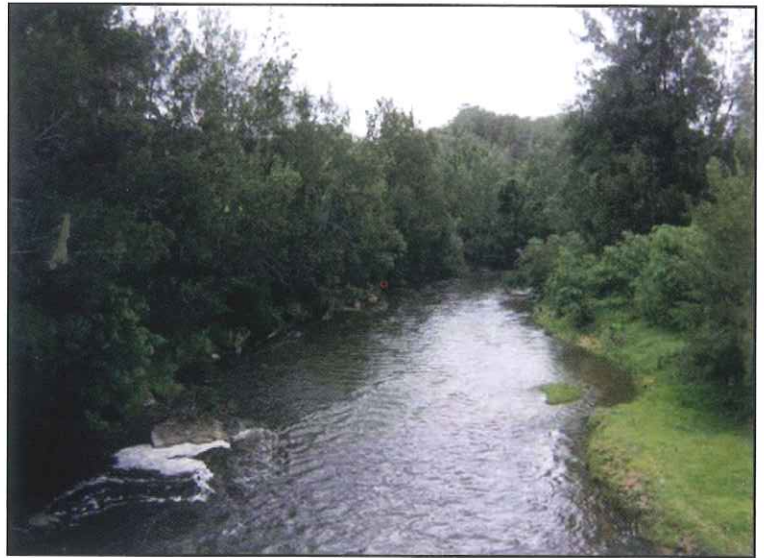
1996: Over-wide channel with island beginning to form (*on right*)

This sequence of photos shows how the river oaks have helped to stabilise an in-stream island and narrowed the river channel.

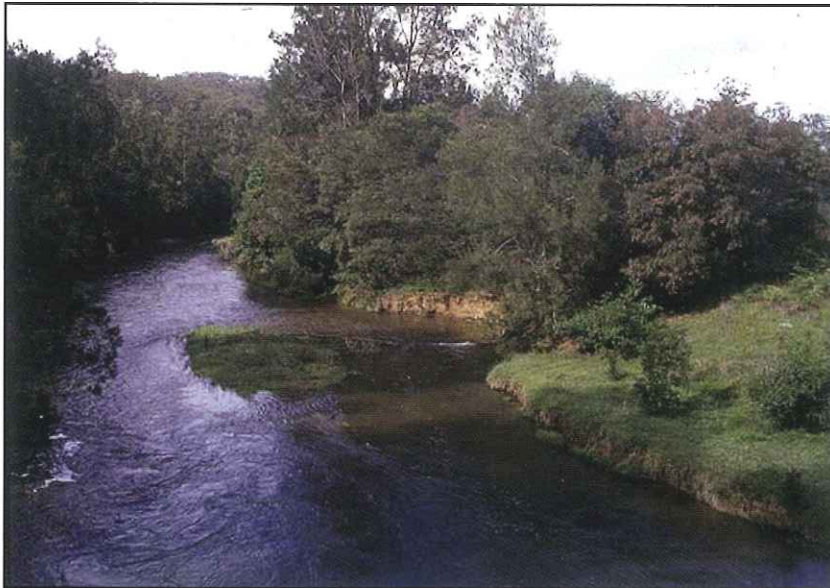
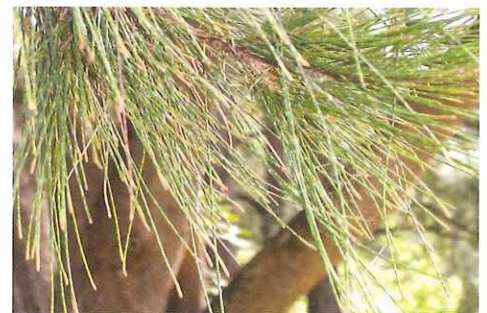
1999: Island is larger and bank erosion more severe (*centre of photo*)
Deposition of gravel continues, the island grows, a riffle develops up stream of the island.

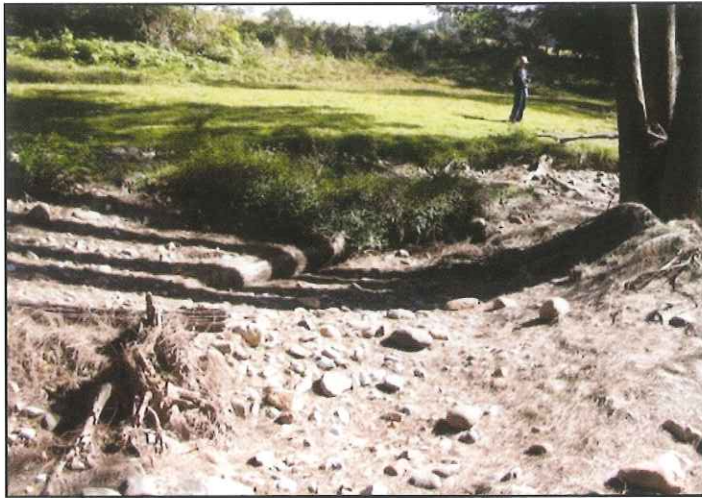
Issue 1: Scouring holes behind large individual river oaks.

Water flow forms eddies behind the stems of large trees and scours holes into the gravel bed.

Planting a greater density of trees and understorey plants (e.g. lomandra) around the trees will dissipate the flow and reduce scouring.

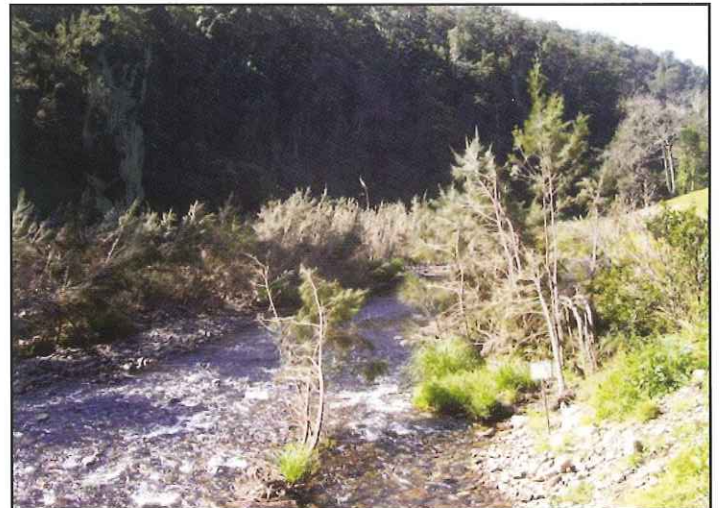
Issue 2: River oaks on gravel island narrow the channel and divert flow towards weak and unprotected bank.

Increase overall bank strength through structural rehabilitation works and revegetation.

Cut or thin River Oaks to allow high flow over the gravel bed.

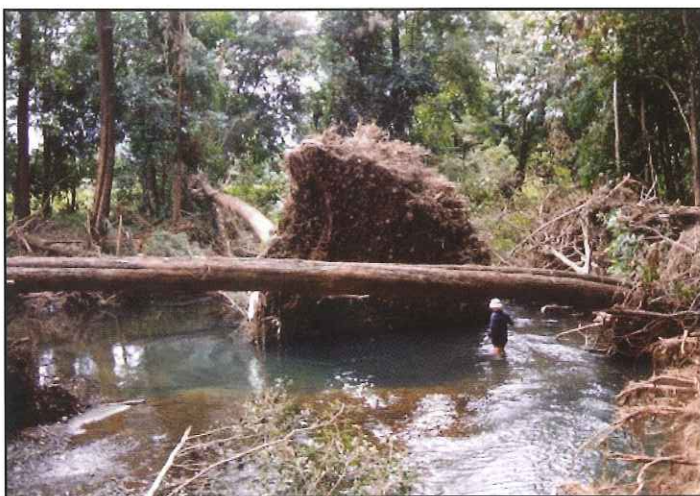
Issue 3: Mature river oak fallen into the river bed and threatening to deflect flows into river bank.

Pull trunk and rootball in against the bank with the rootball facing upstream and oriented away from the bank towards the channel. Depending on the size of the tree it may need to be anchored in place.

Increase overall bank strength by planting a wider vegetated zone on top of the bank.
